Roller Testing to Mimic Damage of the ISS SARJ Ring and Durability Test to Simulate 15 Years of SARJ Operation Using the Damaged Surface

*Timothy L. Krantz, Justin P. Elchert, Christopher DellaCorte, and Michael J. Dube
Glenn Research Center, Cleveland, Ohio*

Glenn Research Center
Cleveland, Ohio 44135

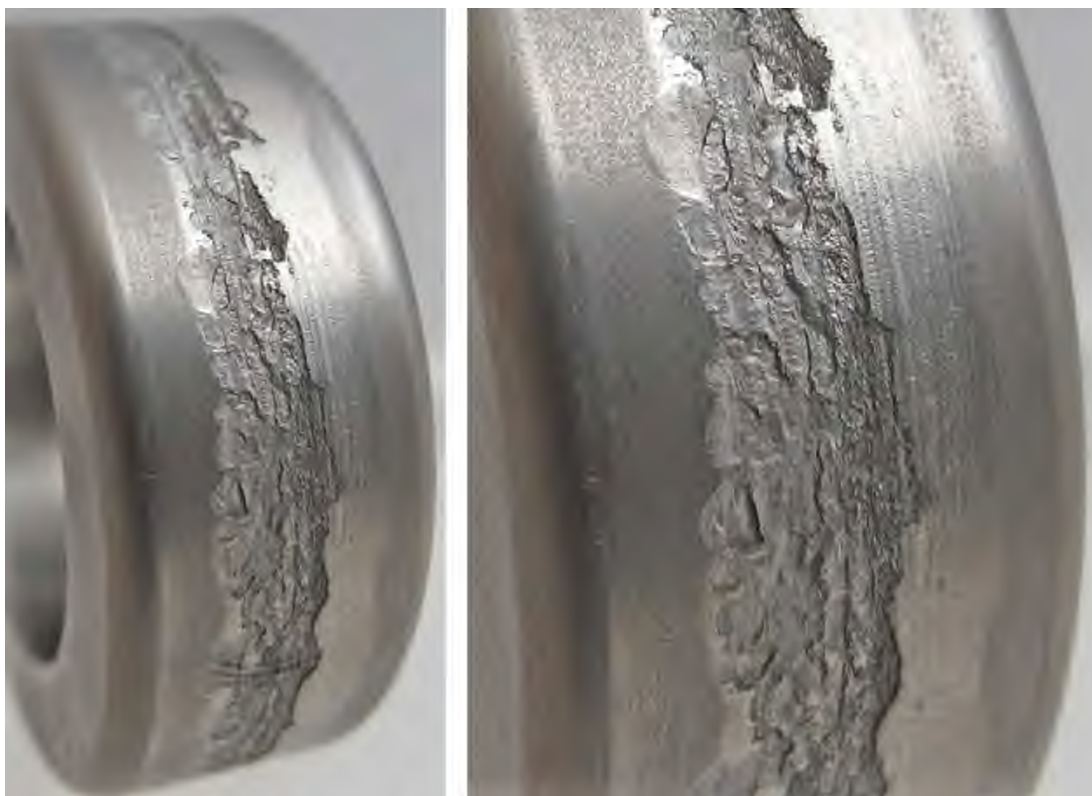
Figure 33.—Condition of the nitrided roller after the damage propagation test, circumferential location 3.

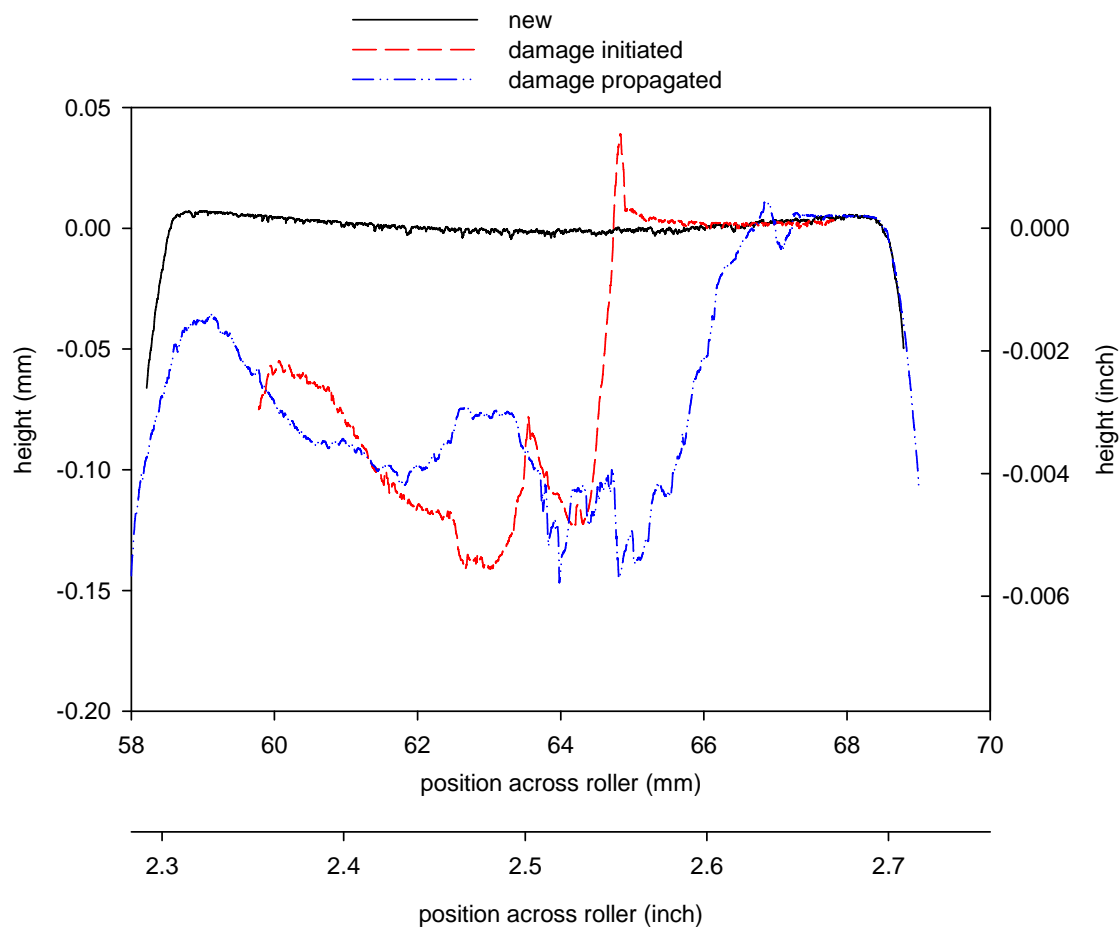
Figure 34.—Profile traces across the roller width documenting the new condition, condition after damage initiation testing, and condition after damage propagation testing, circumferential position #7.

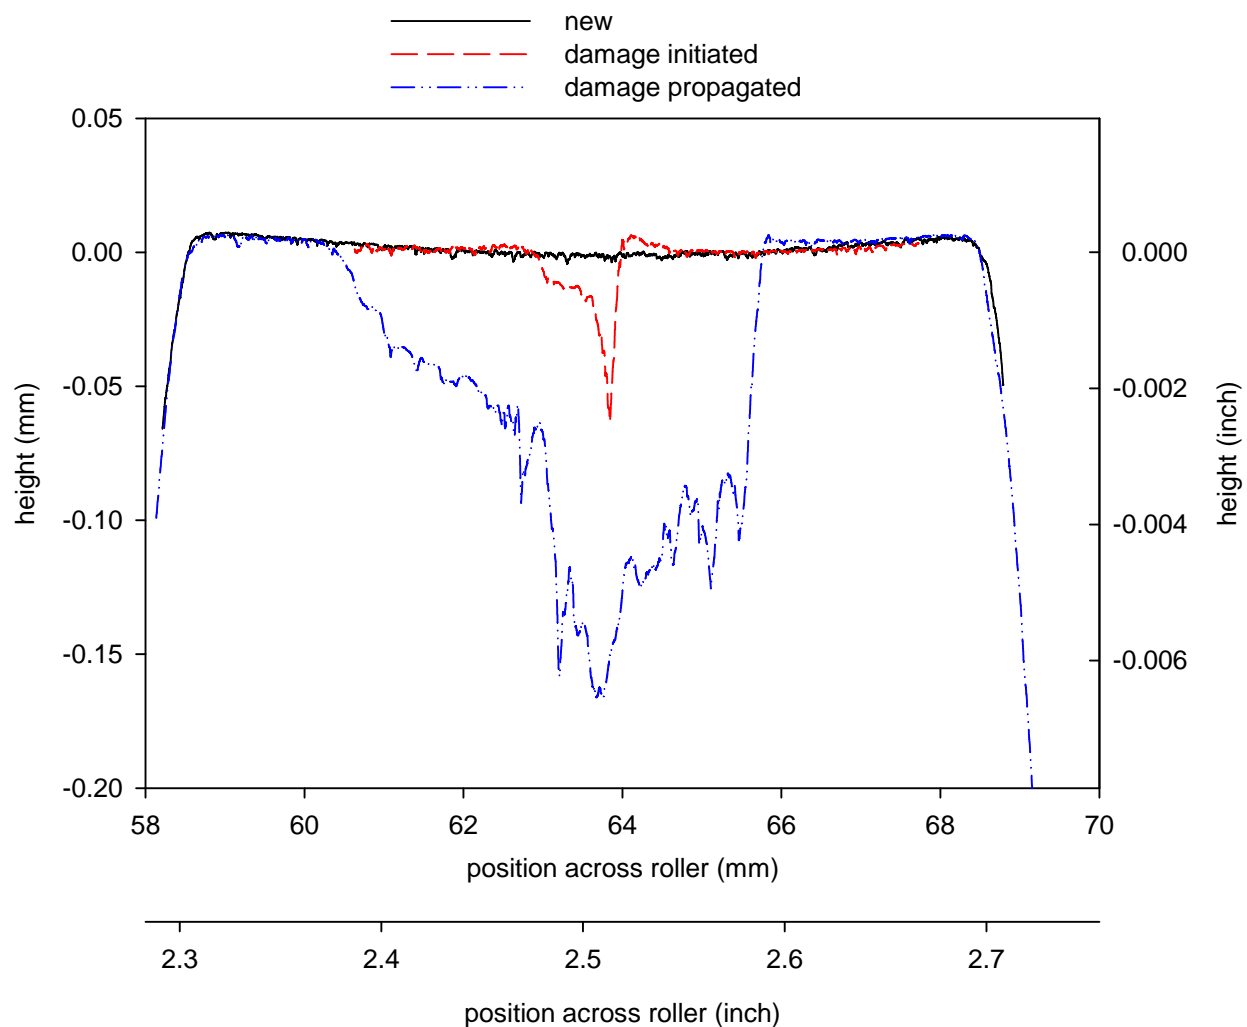
Figure 35.—Profile traces across the roller width documenting the new condition, condition after damage initiation testing, and condition after damage propagation testing, circumferential position #2.

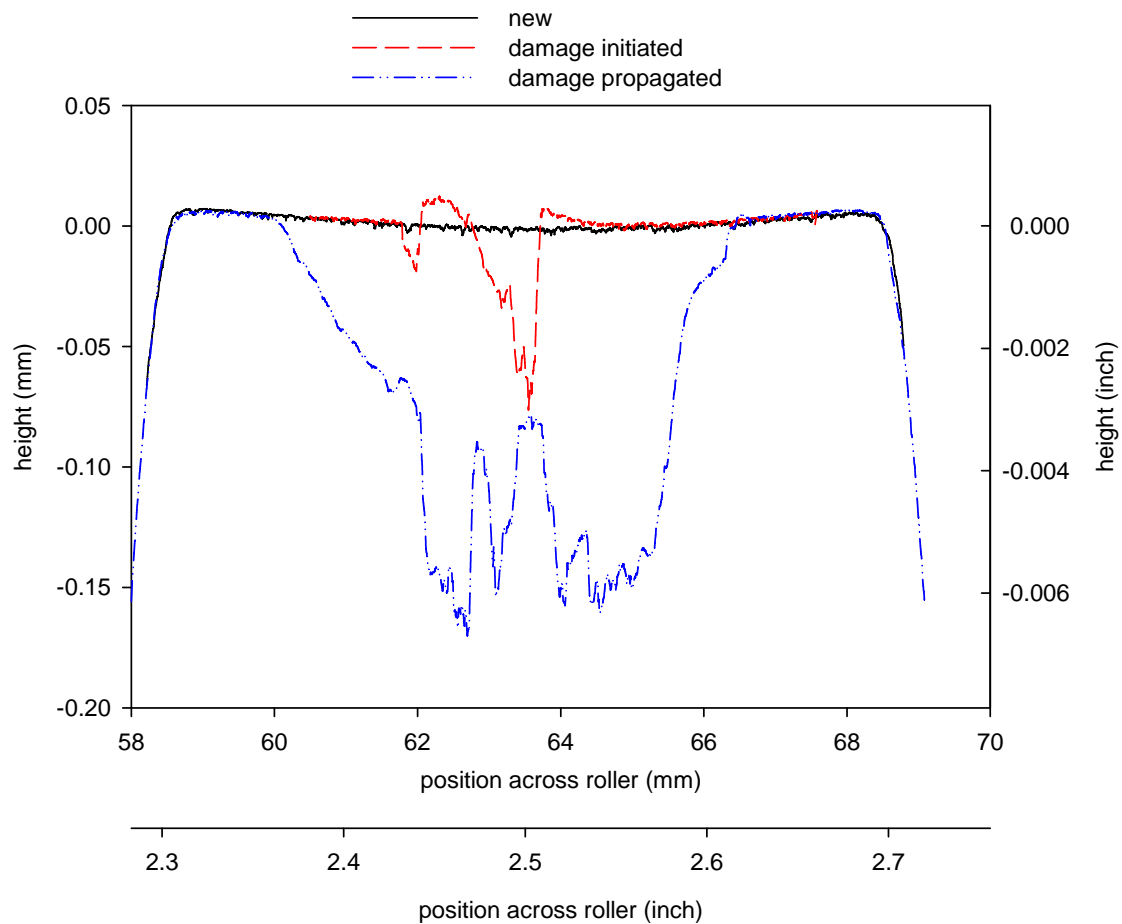
Figure 36.—Profile traces across the roller width documenting the new condition, condition after damage initiation testing, and condition after damage propagation testing, circumferential position #2.

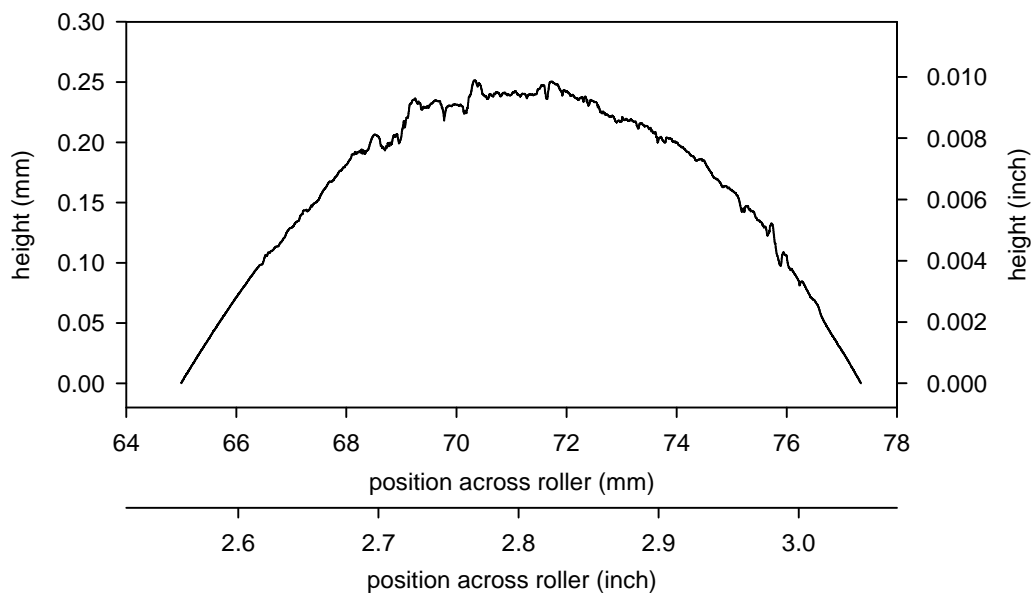
Figure 37.—Profile of the 440C roller at end of the damage propagation testing.

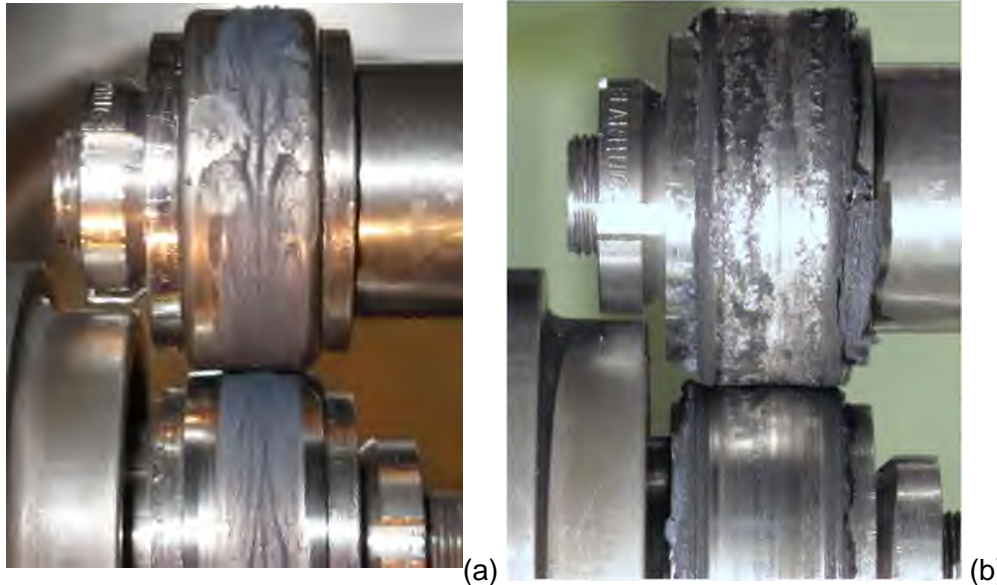
Figure 38.—Typical view of test rollers during a re-greasing action. (a) View after application of grease. (b) View of the same rollers at end of a testing interval.

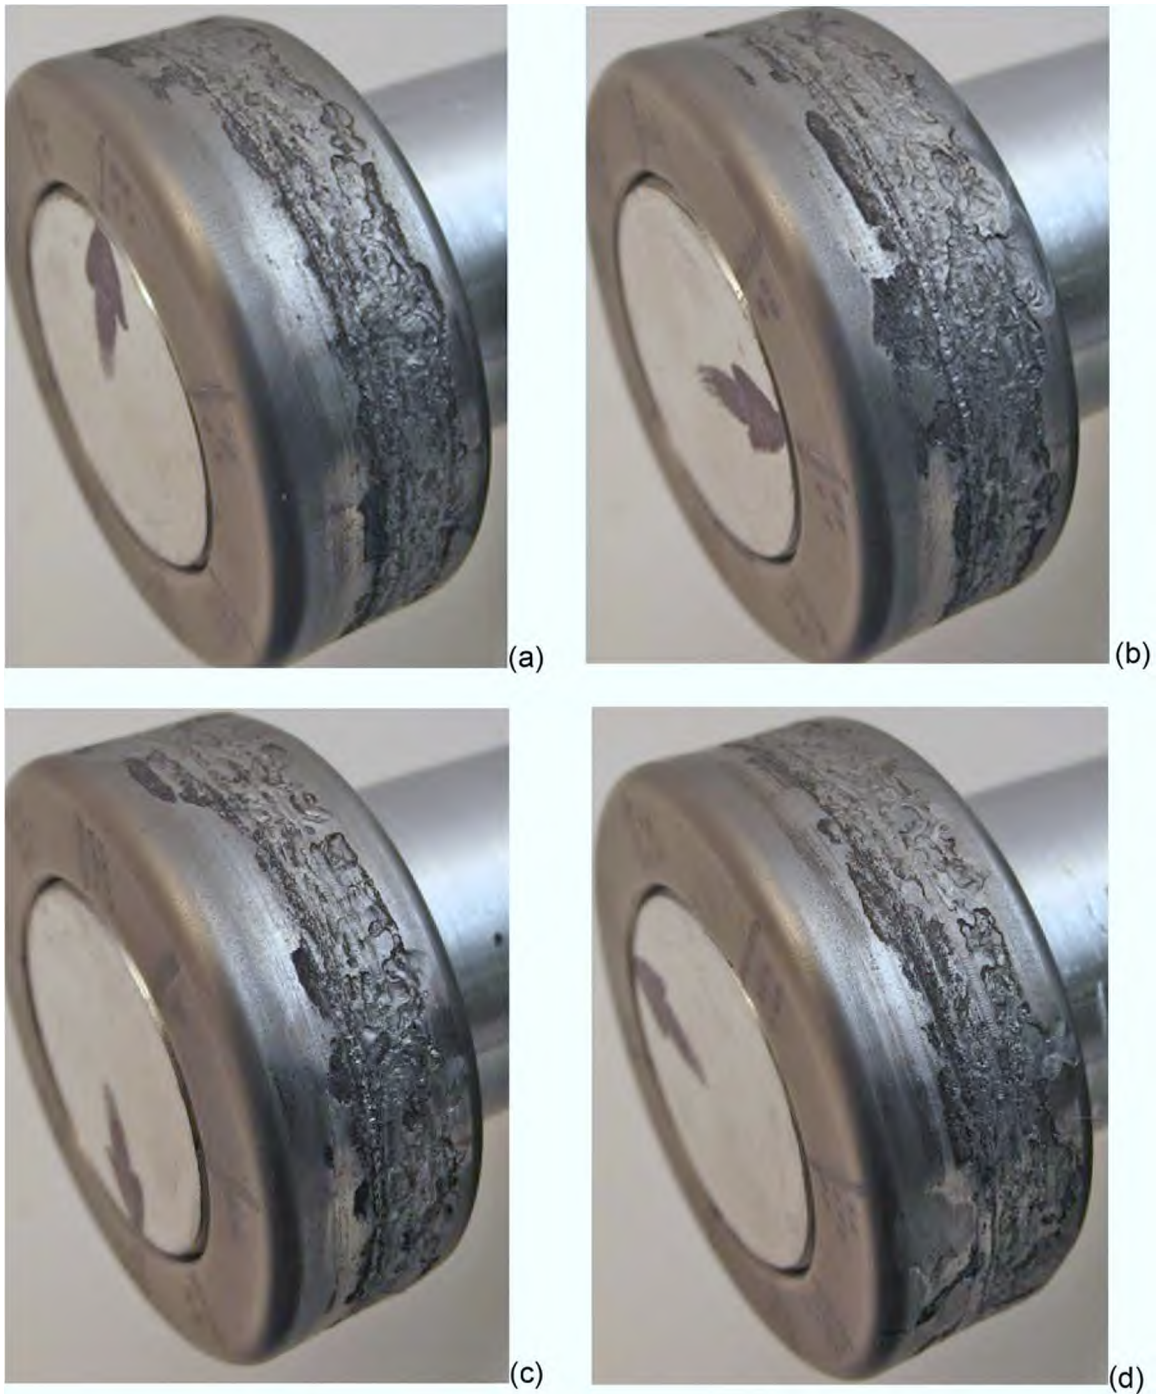
Figure 39.—Condition of nitrided 15-5 roller after completion of durability test interval 3 (25,864 durability cycles). Views (a) to (d) are sequentially rotated 90° per arrow mark on end of shaft.

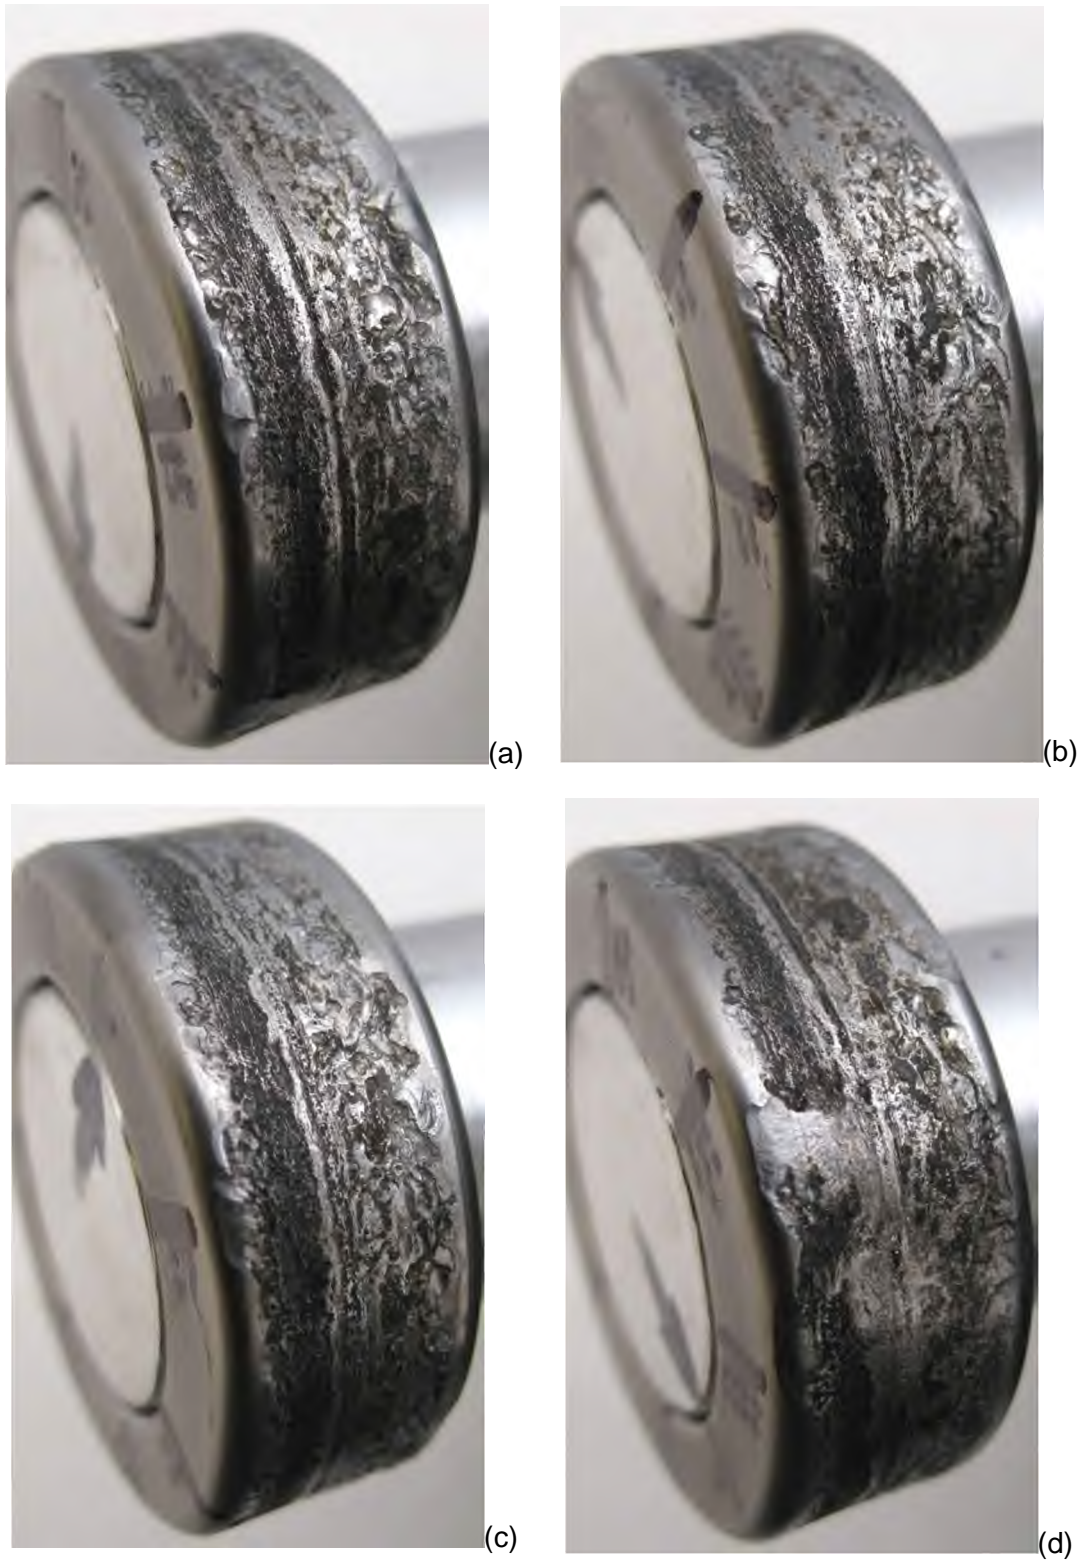
Figure 40.—Condition of nitrided 15-5 roller after completion of durability test interval 6 (407,514 durability cycles). Views (a) to (d) are sequentially rotated 90° per arrow mark on end of shaft.

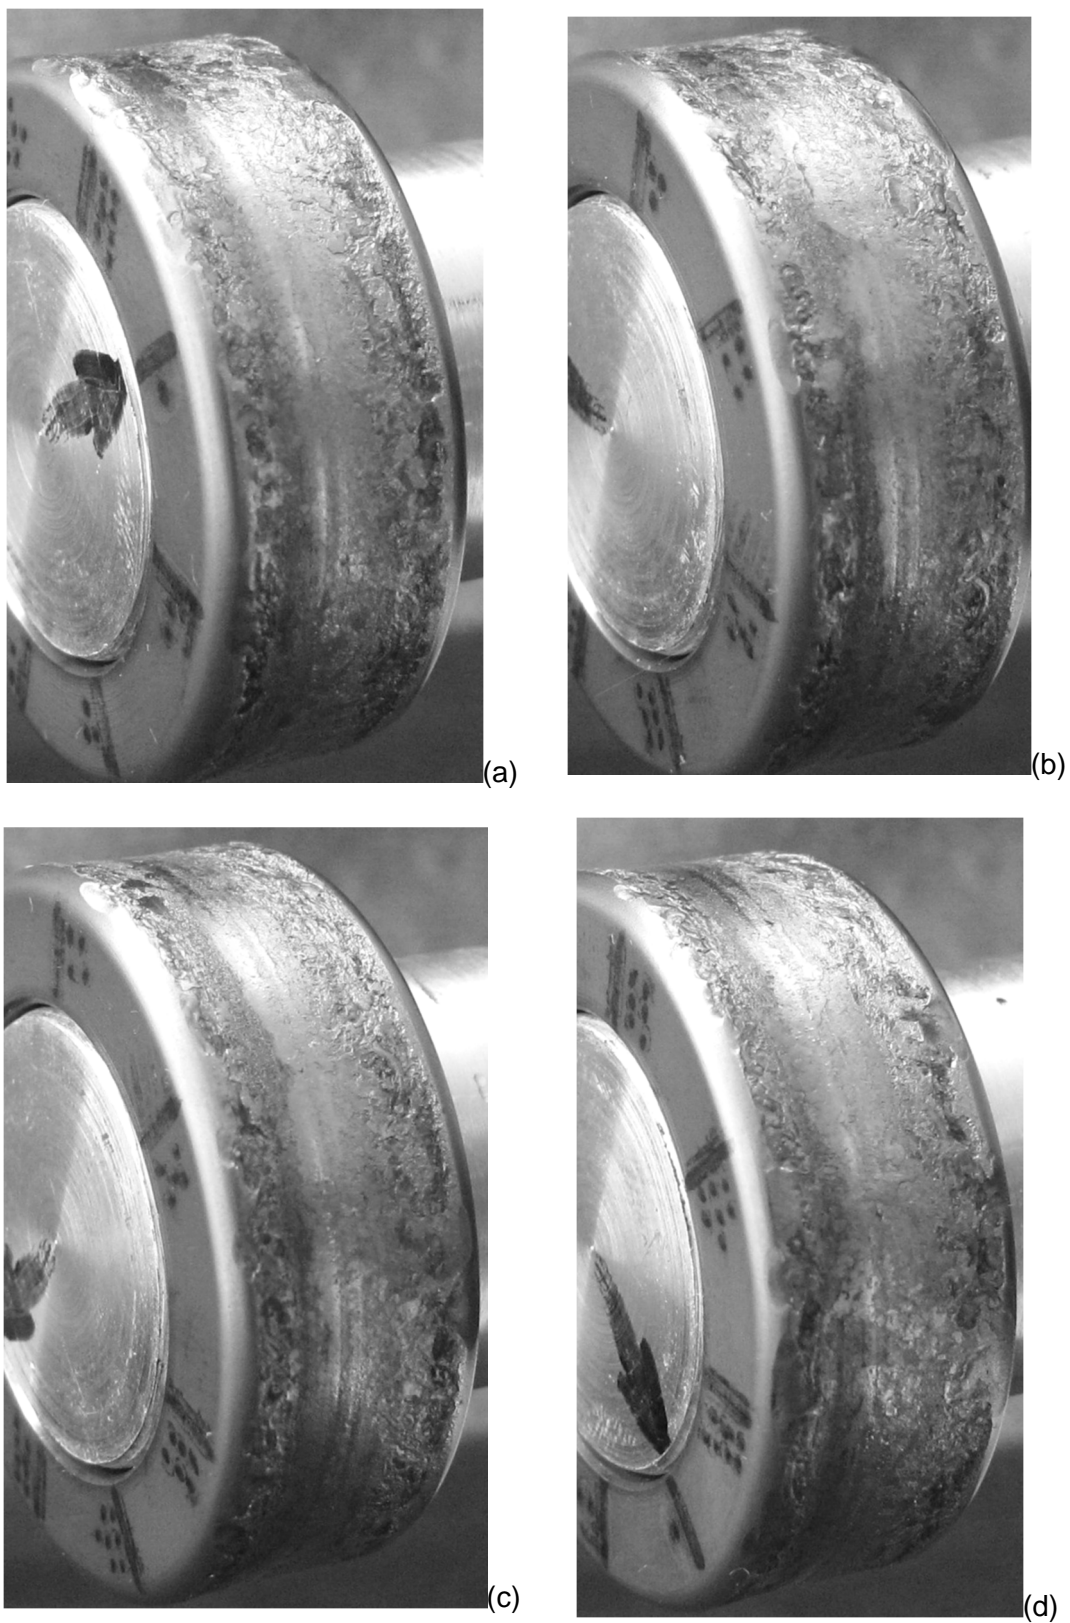
Figure 41.—Condition of rollers after completion of durability test (1.39 million durability cycles). Views (a) to (d) are sequentially rotated 90° per arrow mark on end of shaft.

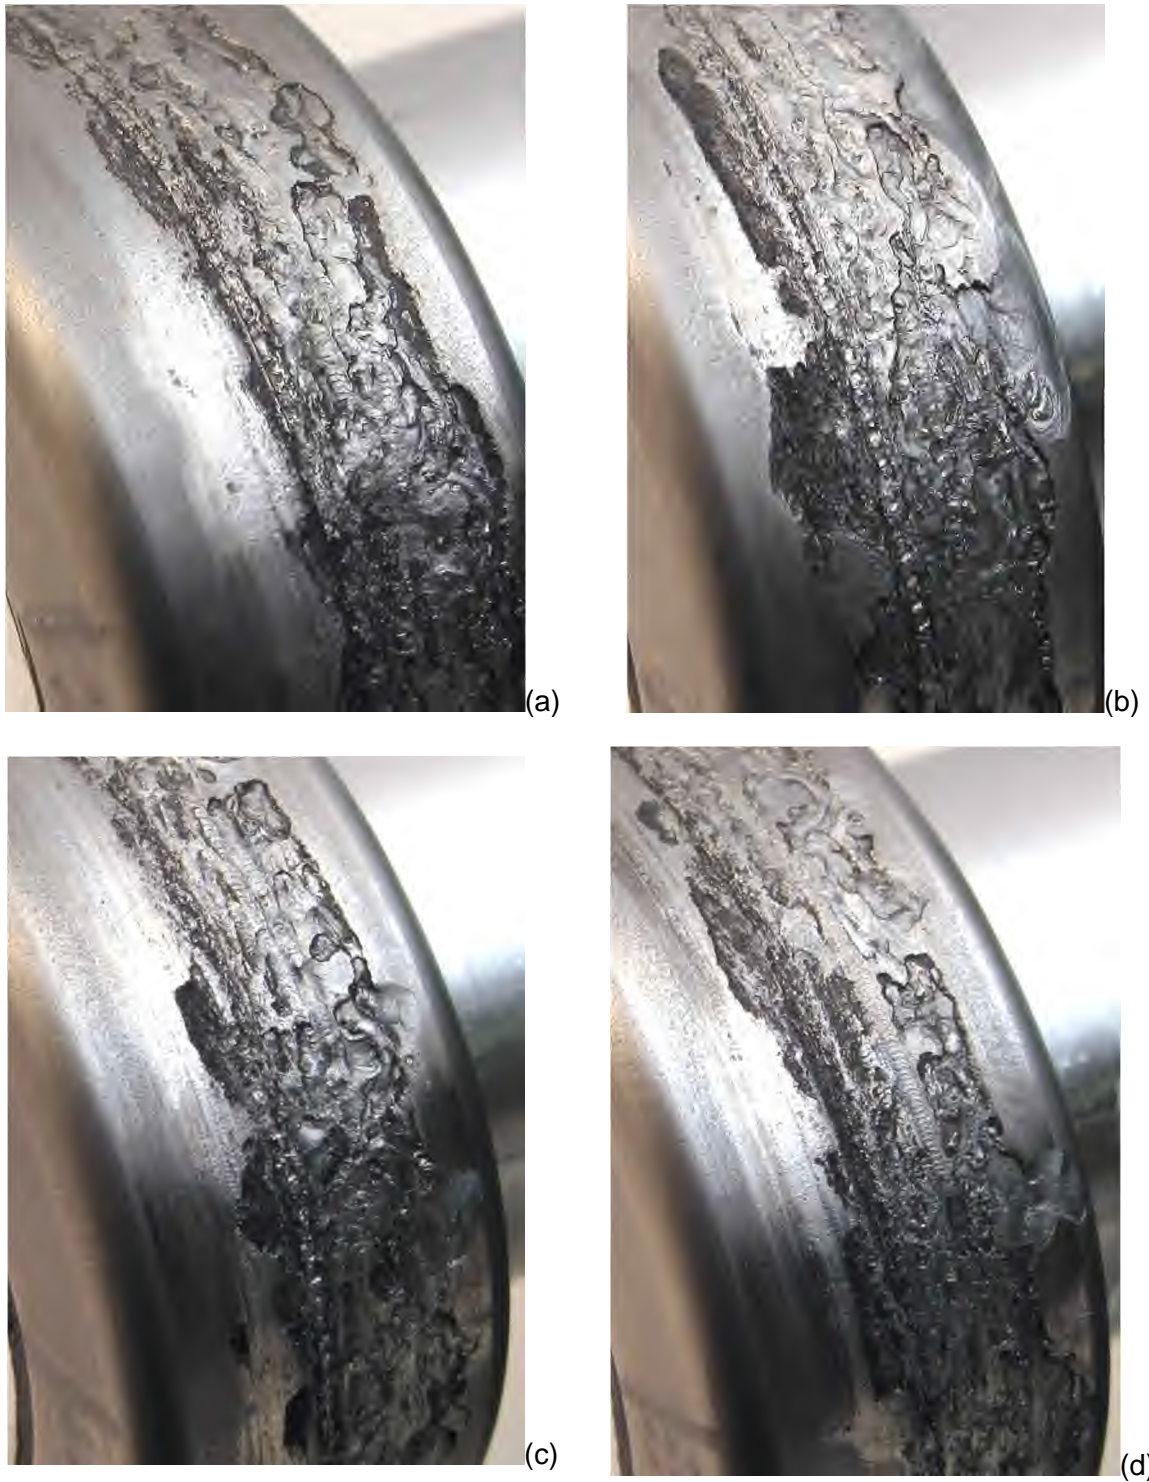
Figure 42.—Condition of nitrided 15-5 roller after completion of durability test interval 3 (25,864 durability cycles). Views (a) to (d) are sequentially rotated 90° as Figure 39 but with magnified view of details.

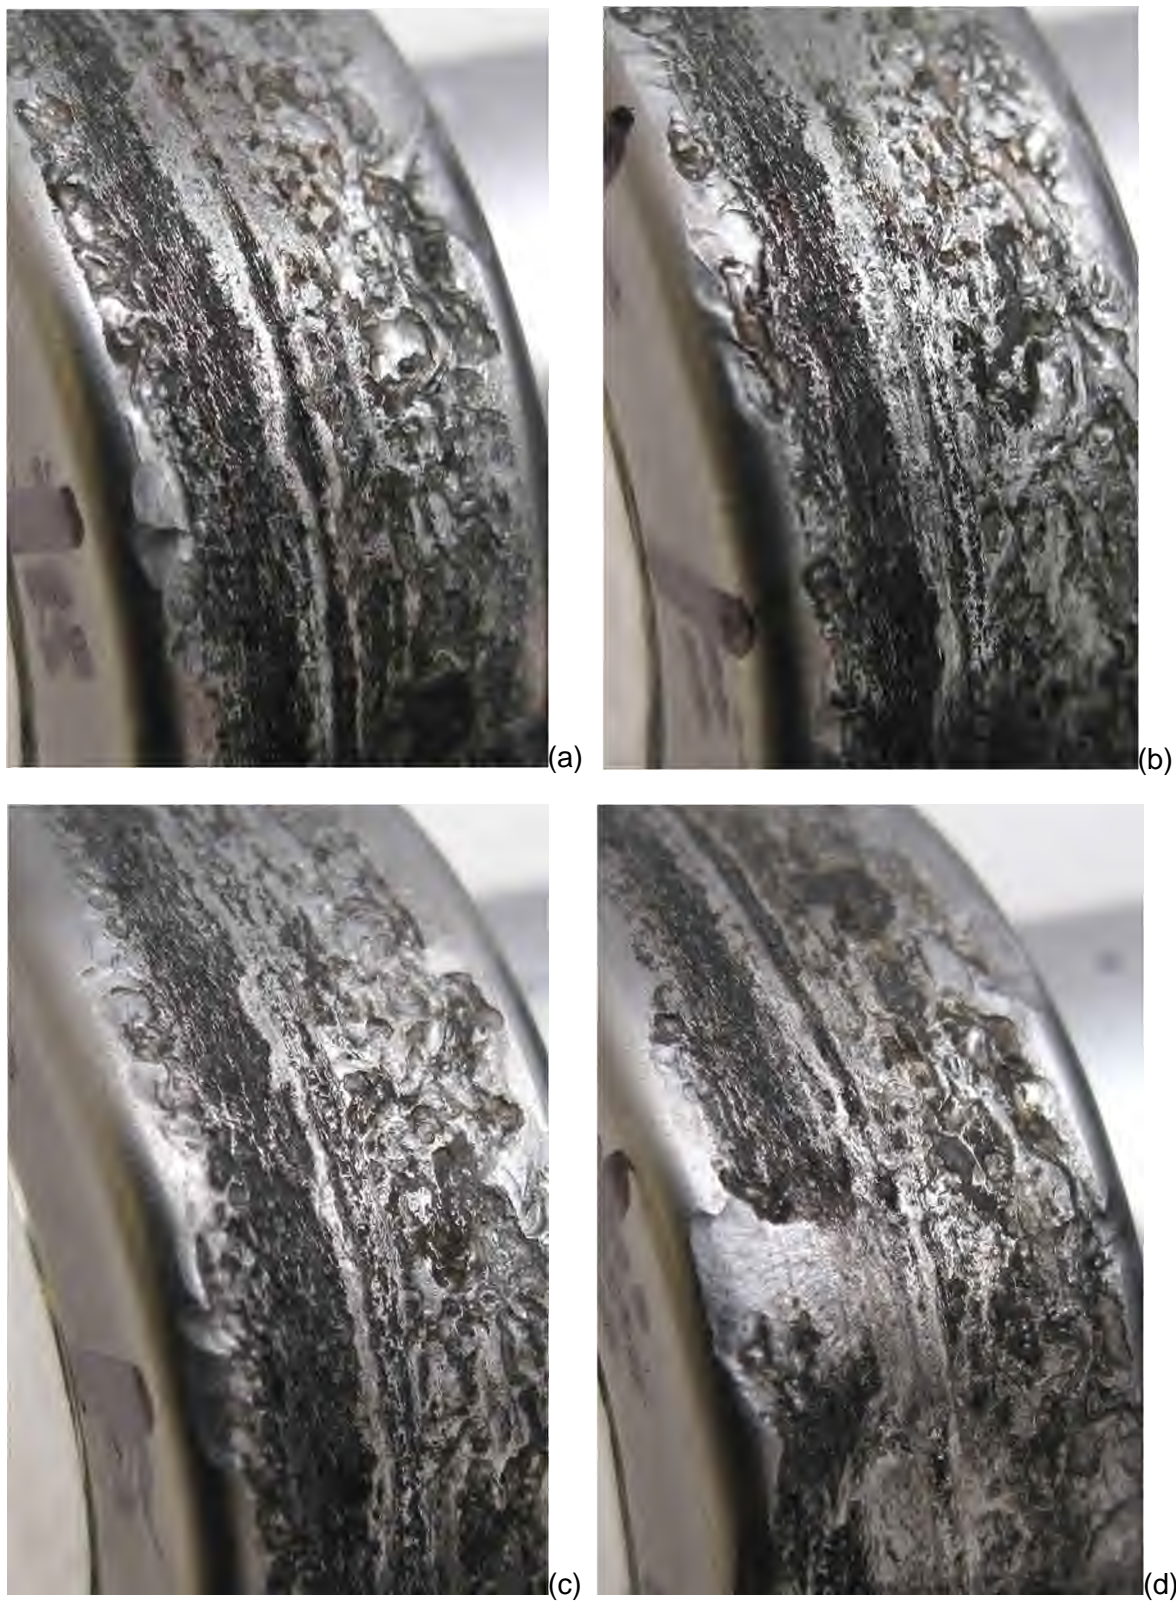
Figure 43.—Condition of nitrided 15-5 roller after completion of durability test interval 6 (407,514 durability cycles). Views (a) to (d) are sequentially rotated 90° as in Figure 40 but with magnified view of details.

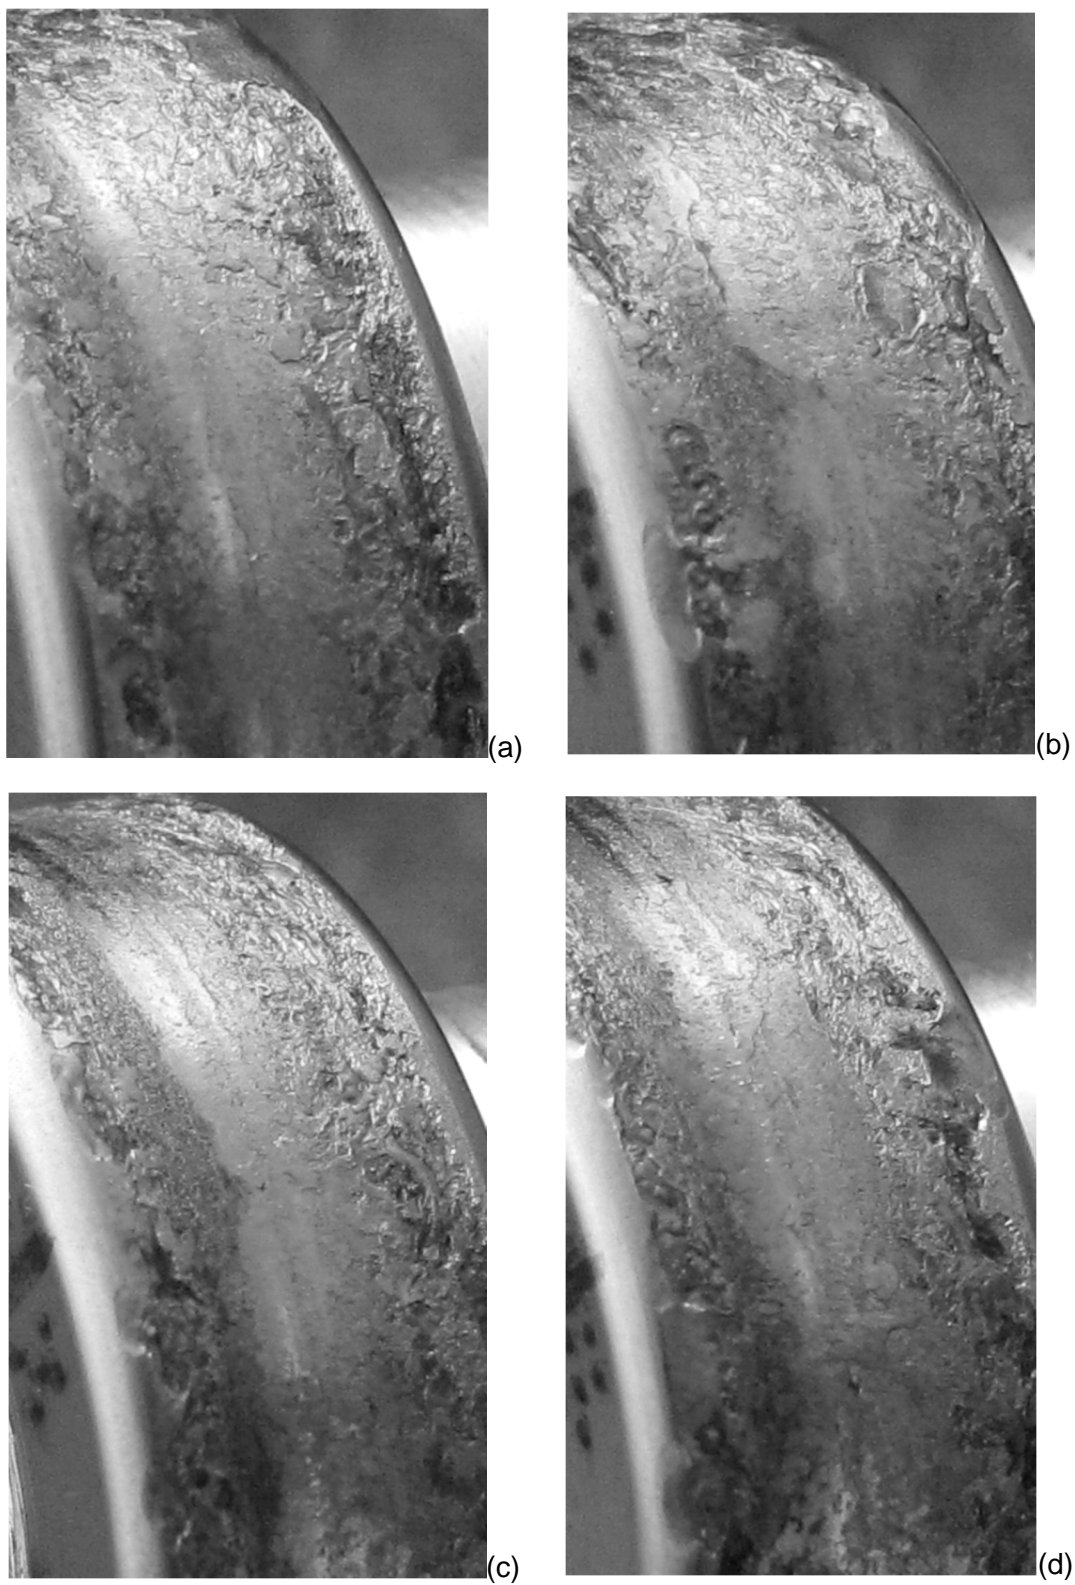
Figure 44.—Condition of nitrided 15-5 roller after completion of durability test (1.39 million durability cycles). Views (a) to (d) are sequentially rotated 90° as in Figure 41 but with magnified view of details.

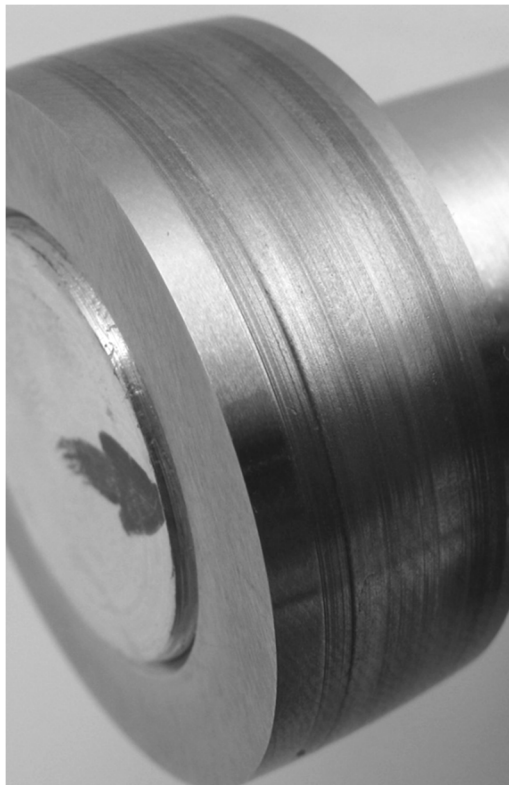
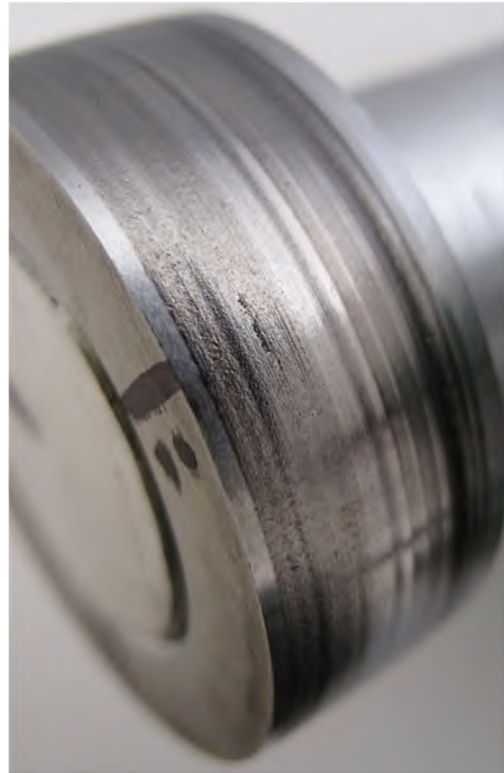
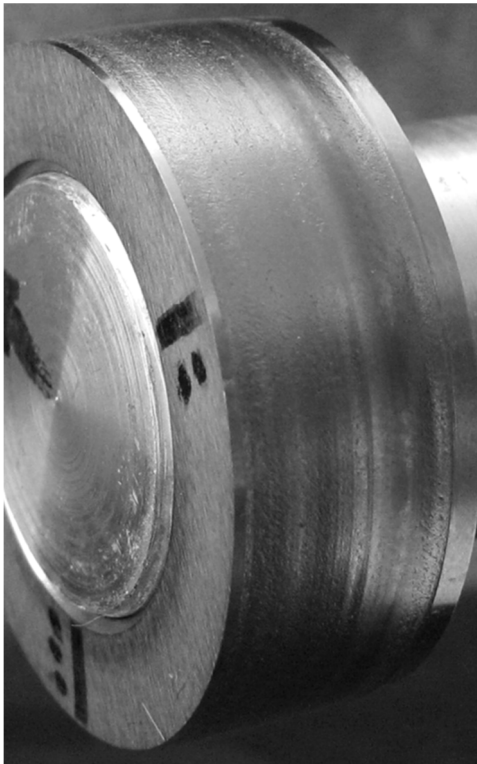
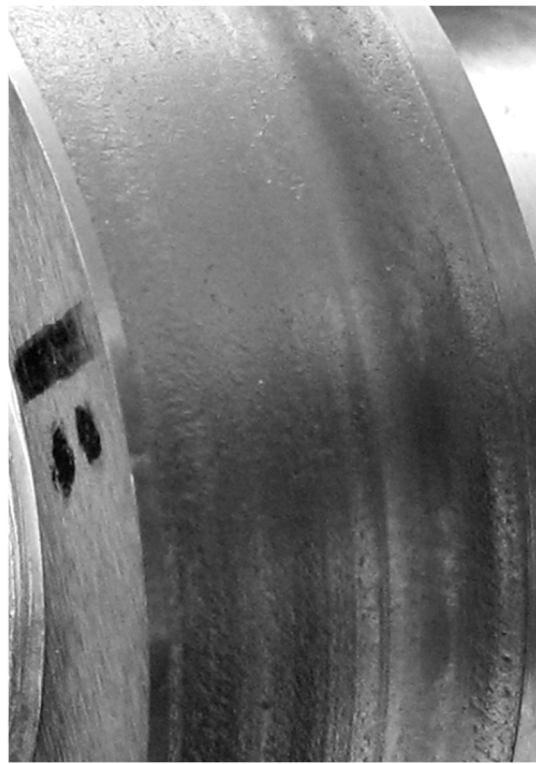
Figure 45.—Condition of 440C roller at intervals of durability test: (a) end of interval 3 (25,864 cycles), (b) end of interval 6 (407,514 cycles), (c) end of test (1.39 million cycles), (d) end of test, magnified view.

The rollers were removed from the test rig for detailed inspections several times. Figures 39 to 45 show views of the roller surfaces at intervals of approximately 0.03, 0.41, and 1.39 million durability cycles. Figures 39 to 41 provide overall views of the nitrided 15-5 roller, and Figures 42 to 44 provide magnified views of the nitrided roller surface. These images show the evolution of the surface damage. The extent of damage after even only 25,864 cycles (Fig. 39) is significantly greater than the beginning of the durability test (Figs. 31 and 32). After 407,514 durability cycles the damage has progressed to cover most of the roller surface (Fig. 40). Although the grease lubrication will provide some wear protection, the compromised nitrided surface layer continues to crumble away in a fairly rapid fashion. The damage processes over the first 400,000 cycles appear to be a combination of brittle fracture by overload, plastic deformation, and over-rolling of debris. The surfaces of the rollers after completion of the test (1.39 million durability cycles) suggest that the fracturing process became completed, and the surface at the end of the test appears to be affected by continued abrasive wear, over-rolling and compacting of debris, and localized plastic deformation. The condition of the mating 440C roller is documented by the images of Figure 45. The 440C roller surface has some shallow grooving during the earlier test intervals (Figs. 45(a) and (b)) when the mating 15-5 roller still had a partial nitride layer surface that is hard and abrasive. At the end of the test (Figs. 45(c) and (d)) the 440C surface was smoothed somewhat, but appears to have been worn to some depth by abrasive wear.

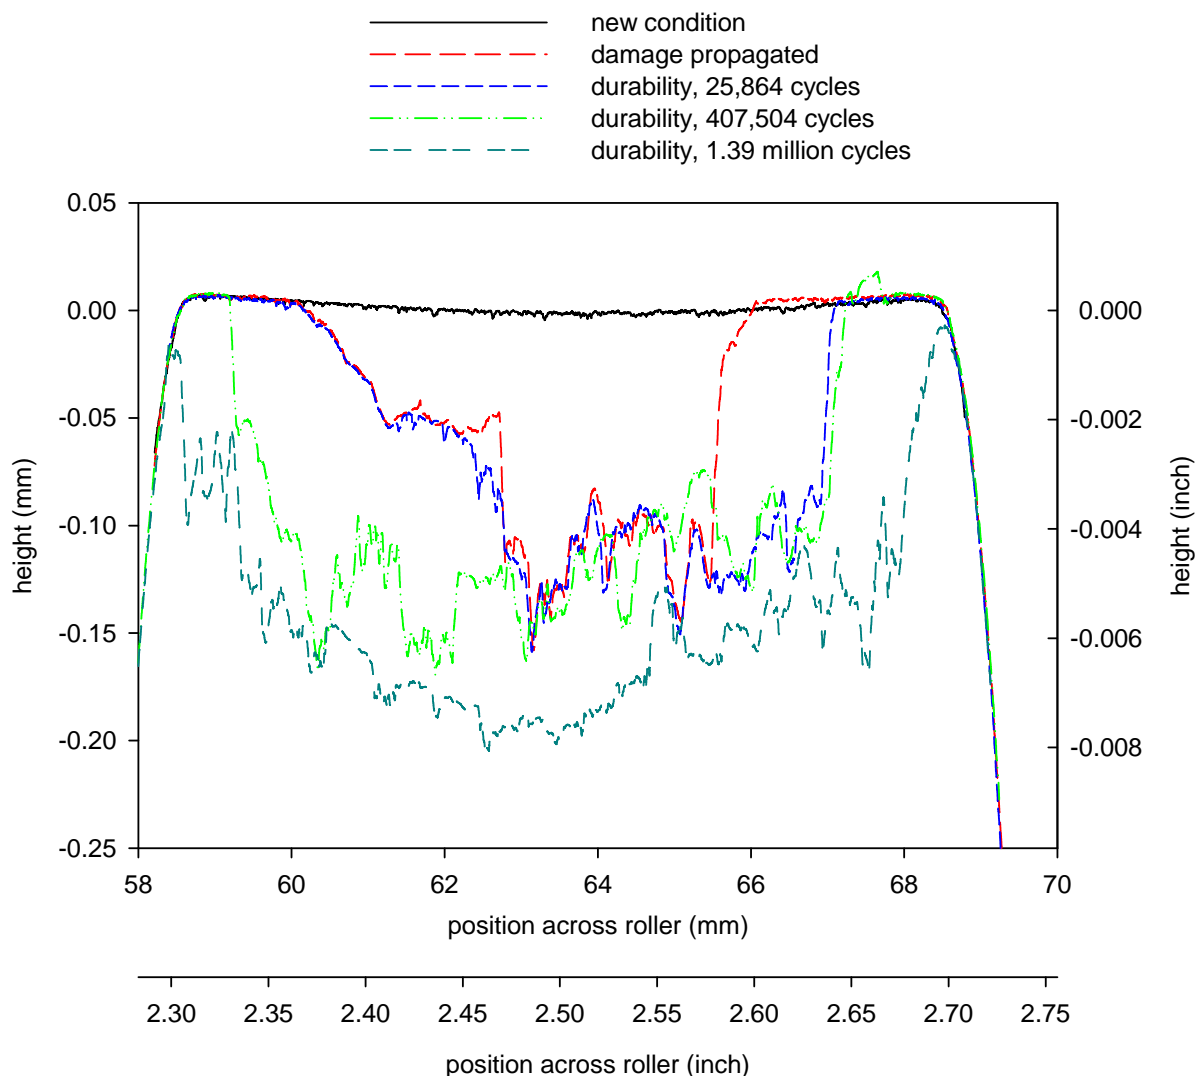
Figure 46.—Profile inspections of the nitrided 15-5 roller at circumferential position #1.

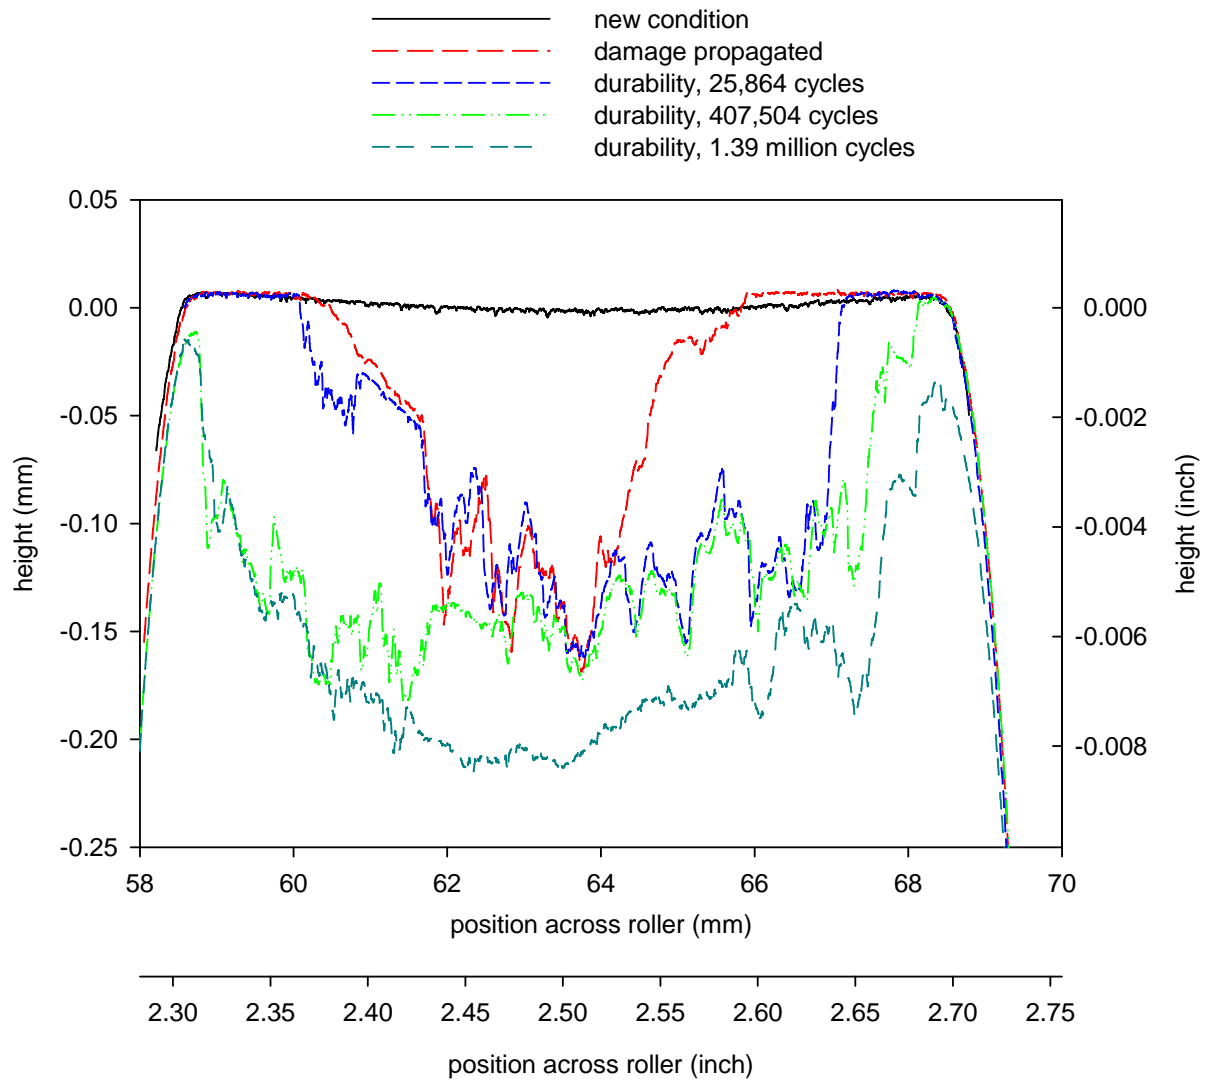
Figure 47.—Profile inspections of the nitrided 15-5 roller at circumferential position #4.

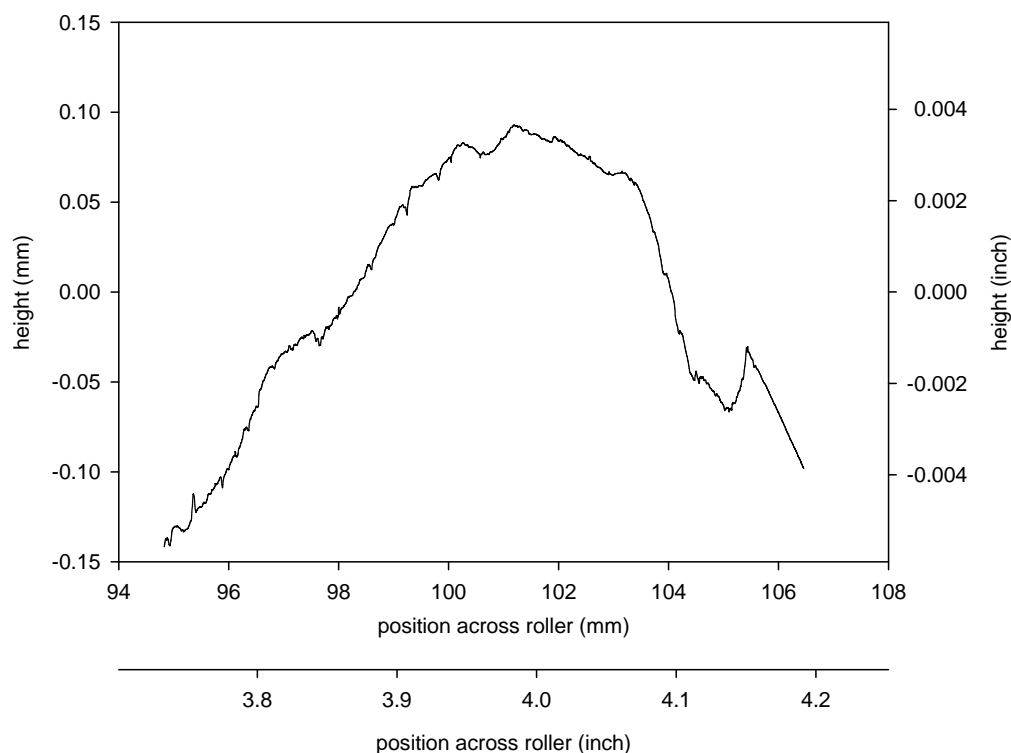
Figure 48.—Profilometer inspection of the 440C roller at the end of the durability test.

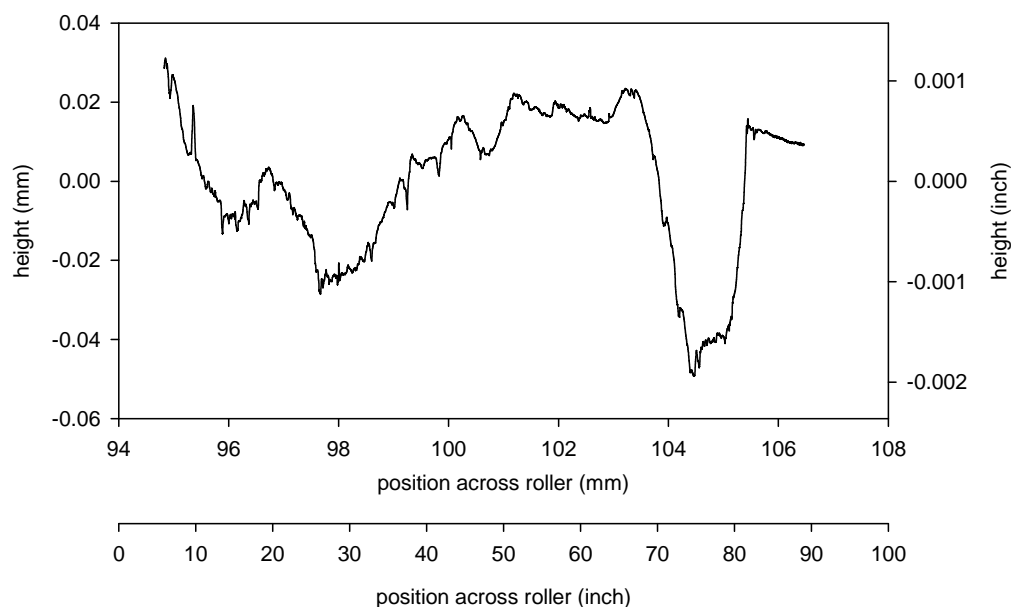
Figure 49.—Profilometer data for the 440C roller at the end of the durability test after removal of arc by least-squares best fit.

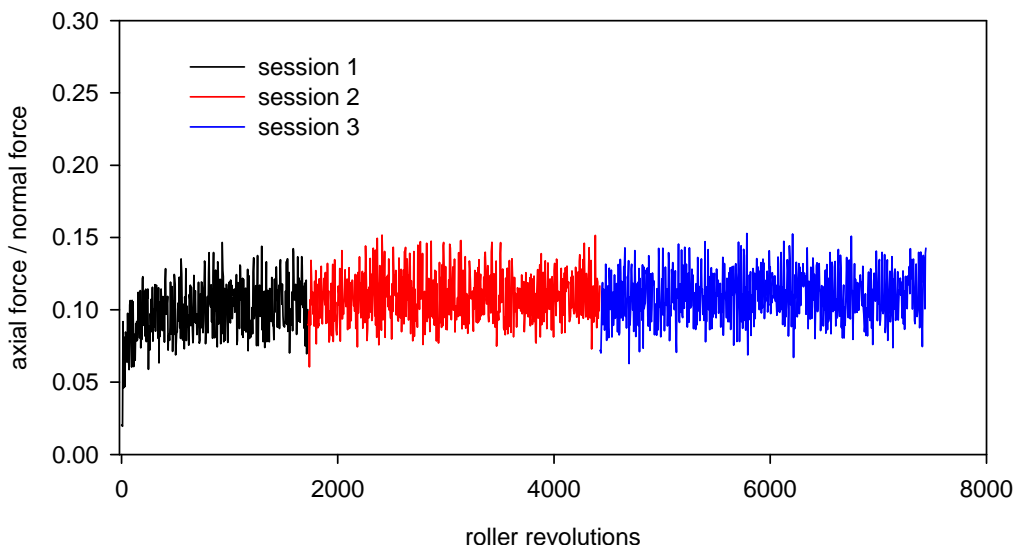
Figure 50.—Trend of thrust load to normal load ratio during testing interval #3 comprising 7,441 roller evolutions.
